## **Structural Condition Assessment of the Lake Shady Dam**

**Oronoco, MN**

**Prepared for: Olmsted County, MN**

**February 2011**

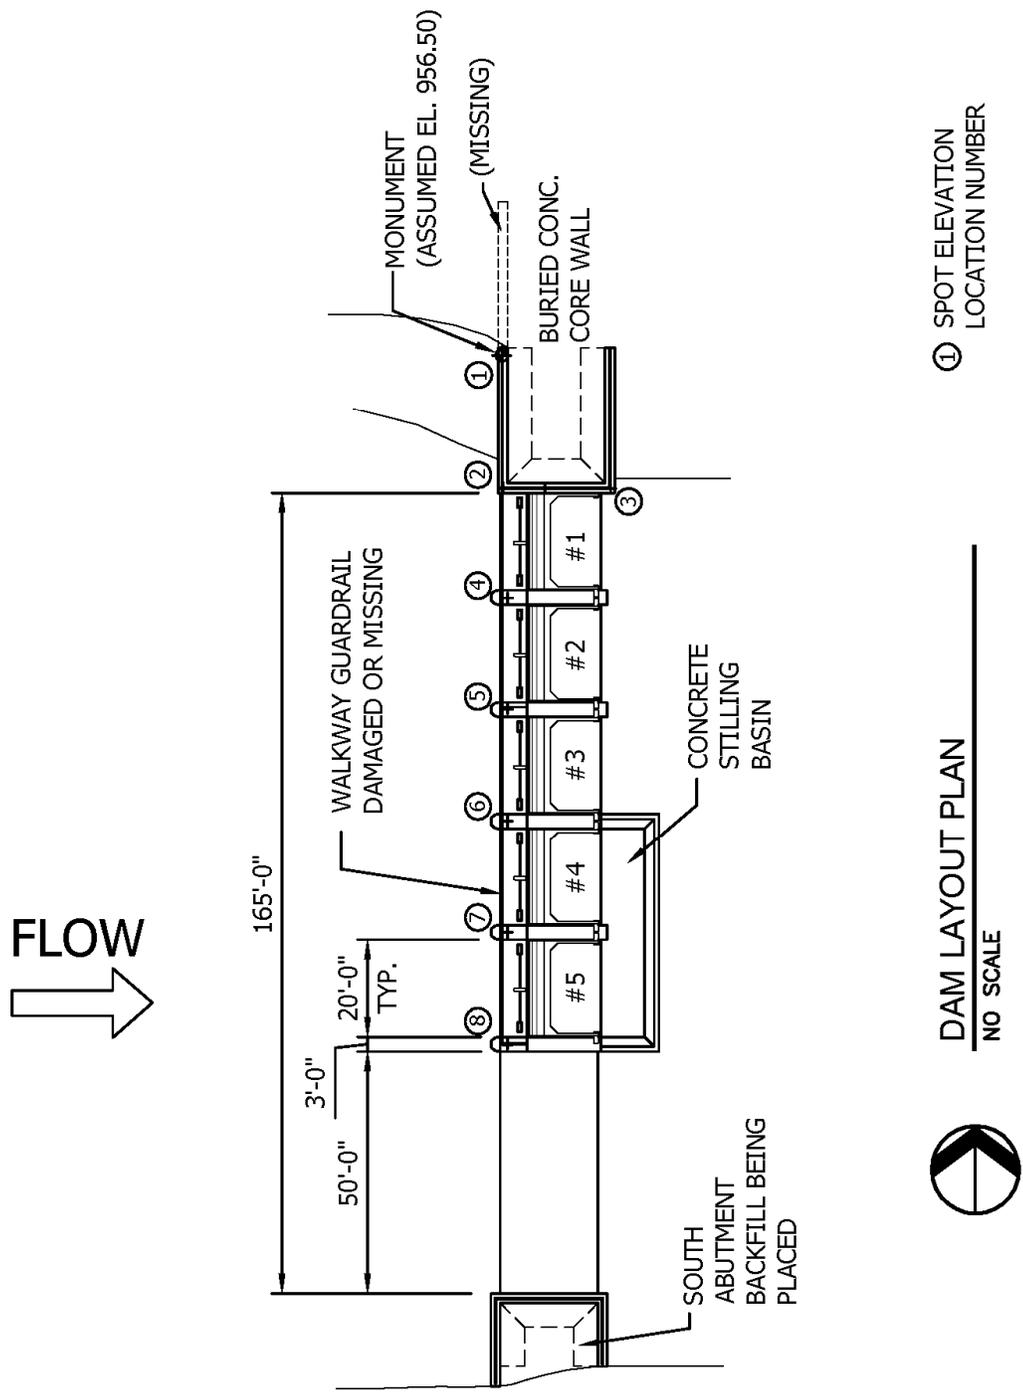
FIGURE: 1

4. Elevations were taken at approximately 23-foot intervals (above each pier) along the walkway, to determine whether the dam had experienced any vertical movement. All elevations were within 0.04' so, in our opinion, no movement has occurred.

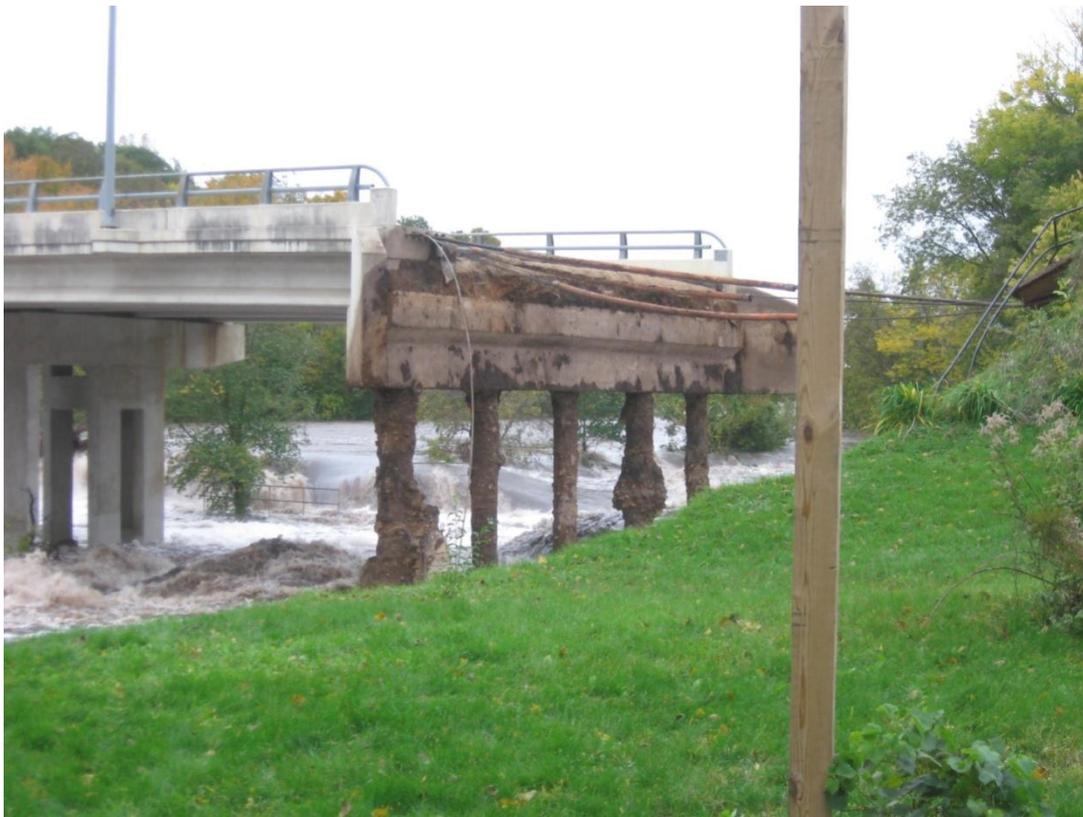
**Photo No. 1 – Dam Overtopping and Bridge Washout at North Abutment (Sept. 2010)**

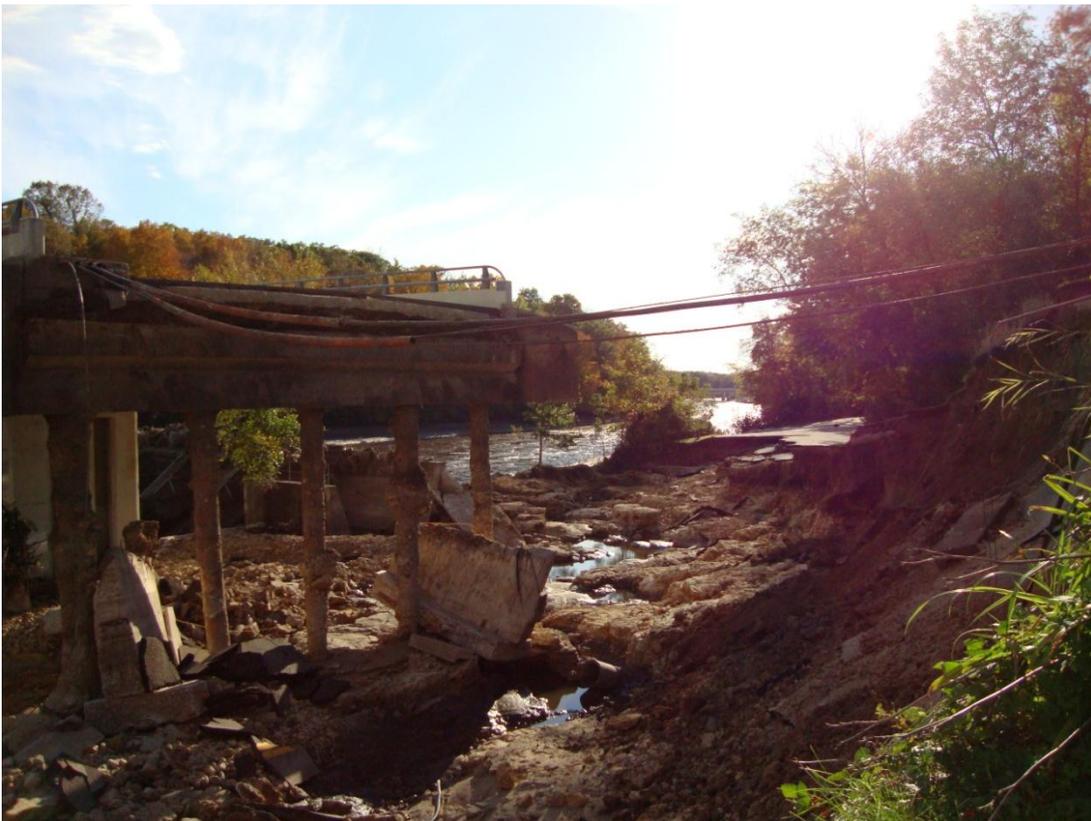
**Photo No. 4 – Washed-out North Embankment (Sept. 2010)**

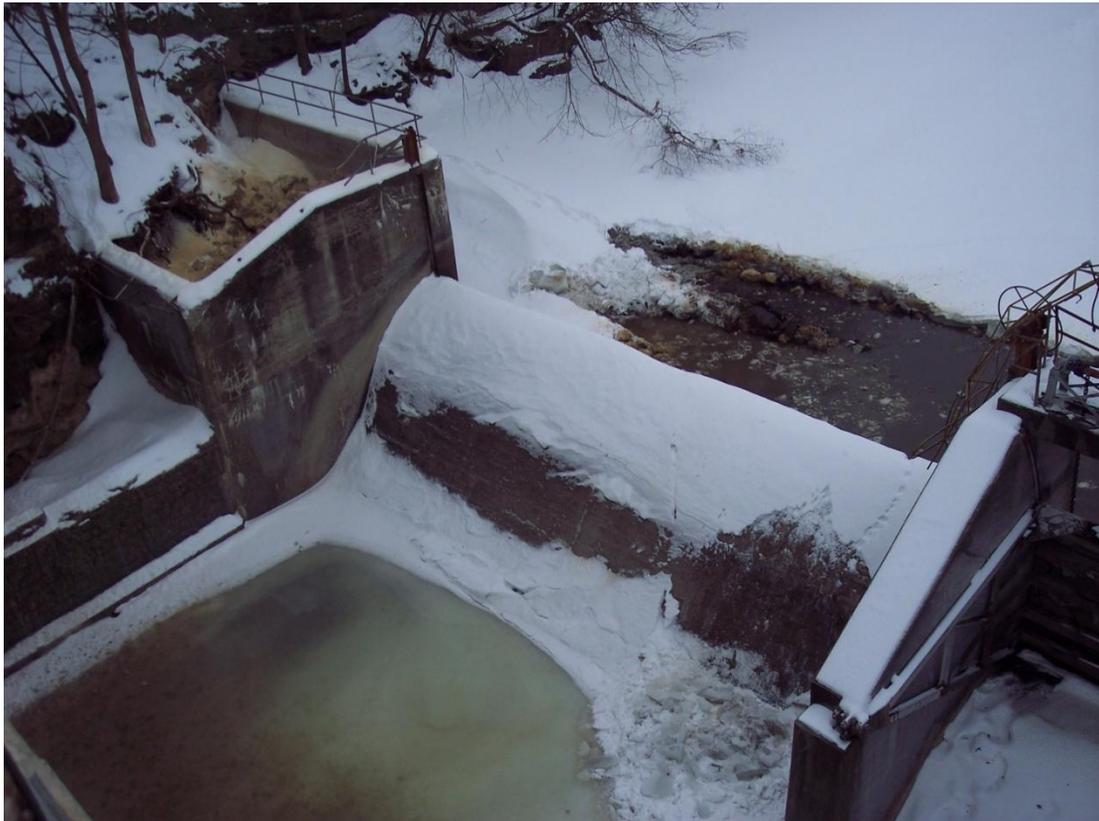
Although the upstream water level was a few feet below the concrete ogee-crest spillway, only a portion of the downstream face was visible, with the top and toe obstructed by ice and snow. Of the visible concrete portion, no structural distress, cracking or movement was observed. The 2-foot high flash board had been removed by the flood, but it appeared that the spillway structure had not sustained any damage. See Photo No. 8.

**Photo No. 8 – Fixed-Crest Spillway**

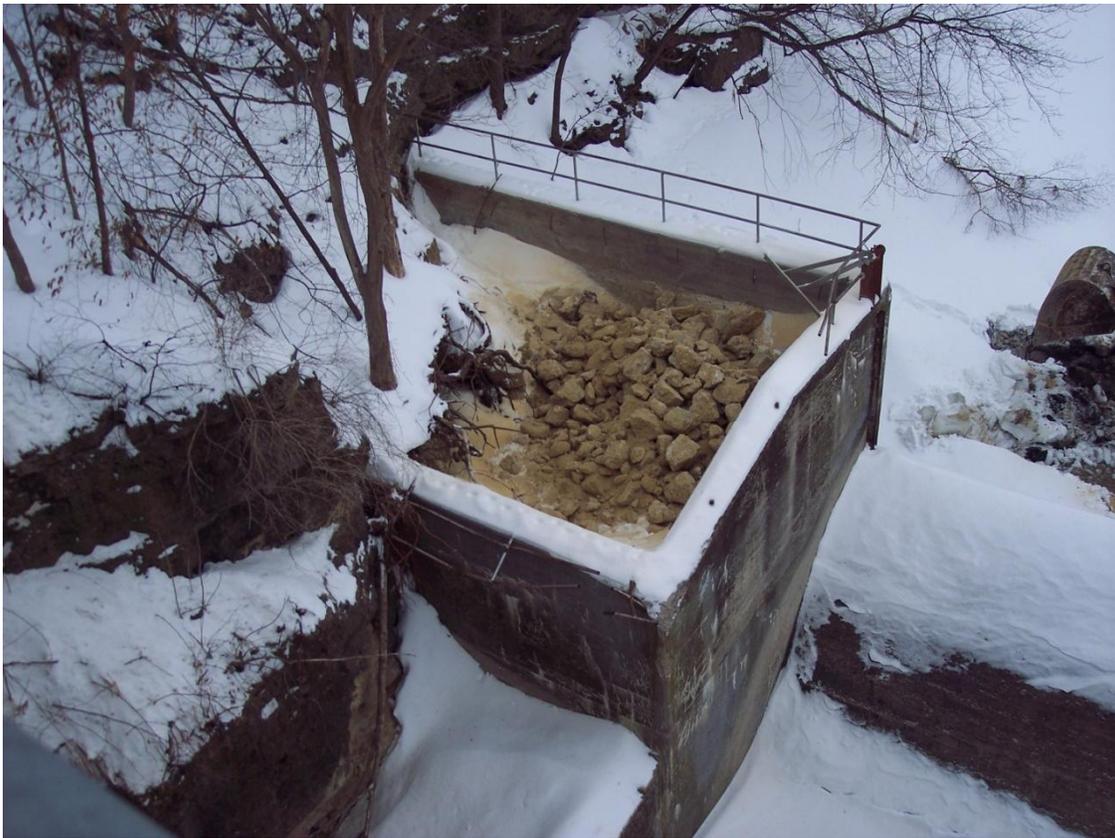
South abutment backfill was lost during the flooding. Minnowa Construction was in the process of placing large (approx. 12" diam.) limestone rip rap backfill at the time of the inspection. No compaction of this material was performed or was even practically possible. See Photo No. 9.

**Photo No. 9 – Right (South) Abutment with New Rip Rap Backfill**

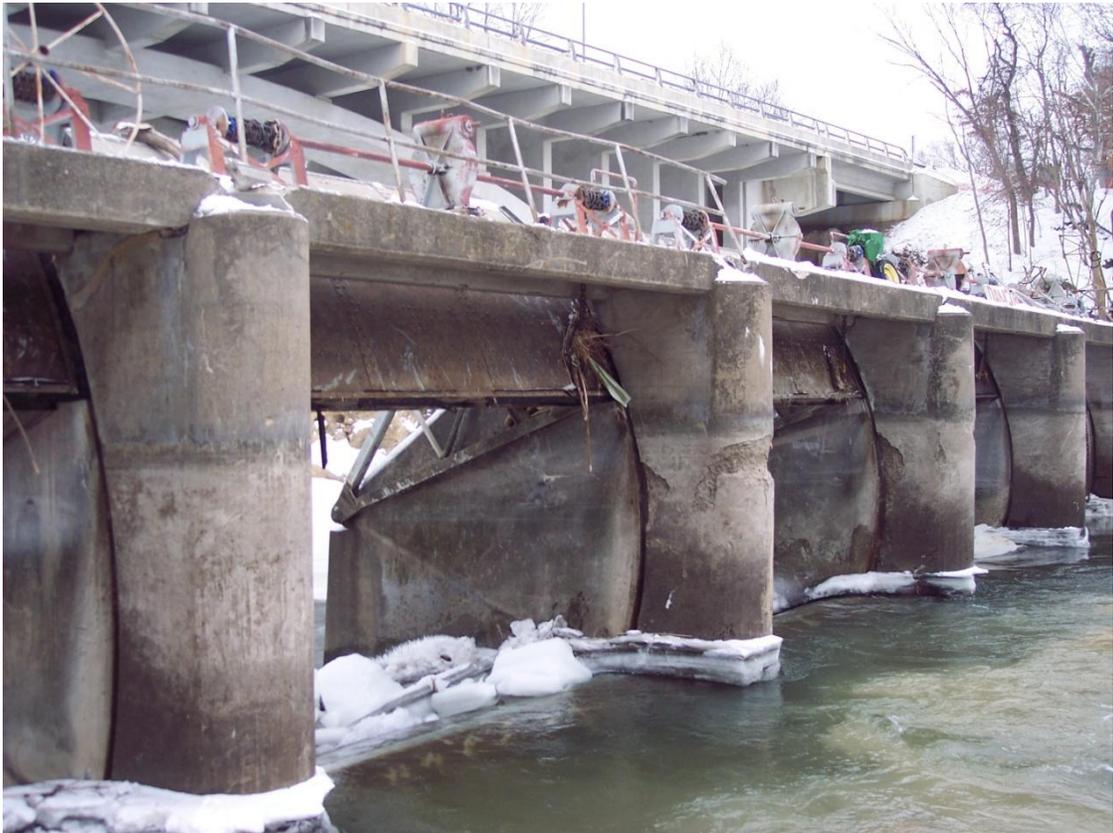
2. Some concrete deterioration was observed, including spalling at Pier Nos. 2 and 3 (See Photo No. 11); surface cracking with efflorescence at the left abutment walls (Photo Nos. 15 and 16); and a diagonal stress crack in right wall of Spillway No. 5. This deterioration does not yet adversely affect the functioning of the dam, but left unaddressed will create problems long term.

3. The steel guardrail on top of the concrete access walkway and wing walls at both abutments was severely damaged by woody debris that collected against it during the flood. In addition, the walkway concrete spalled and was damaged at some of the rail post anchorages. It appeared that these areas had been patched previously, but were damaged during the flood. See Photo Nos. 11 and 12.

**Photo No. 11 – Upstream View of Gated Spillways**

7. Patching the existing concrete is necessary in several locations where cracking and/or spalling was observed. This includes the access walkway and upstream sides of some of the gated spillway piers. See Photo Nos. 11 and 12. Overall, the concrete is exhibiting extensive web-cracking, and efflorescence (white chalky substance), an indication of water penetration. This water penetration will continue to deteriorate the concrete through freeze-thaw cycles, eventually requiring extensive patching. See Photo Nos. 15 and 16.
8. Construct a containment berm along the north embankment, upstream of the dam, as directed by the DNR. This berm is necessary to prevent the possibility of future floods again overtopping the north embankment and bypassing the dam.

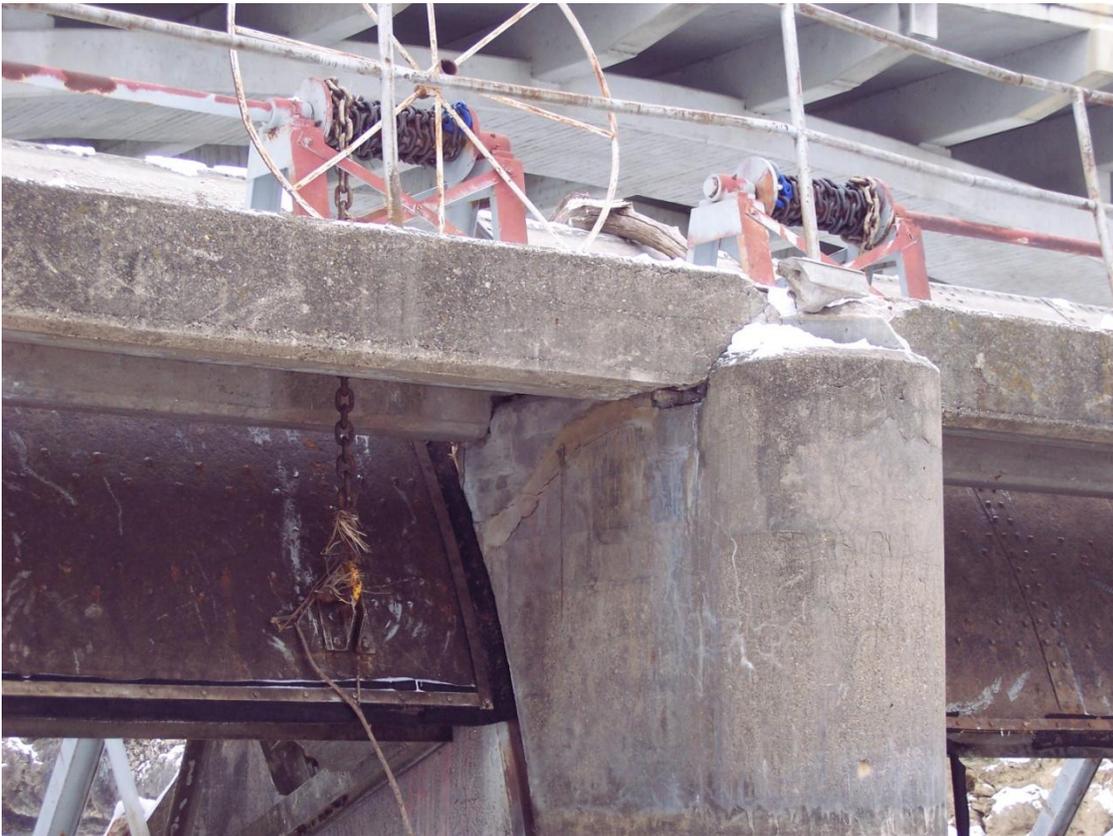
**Photo No. 12 – Deteriorated Concrete Walkway**

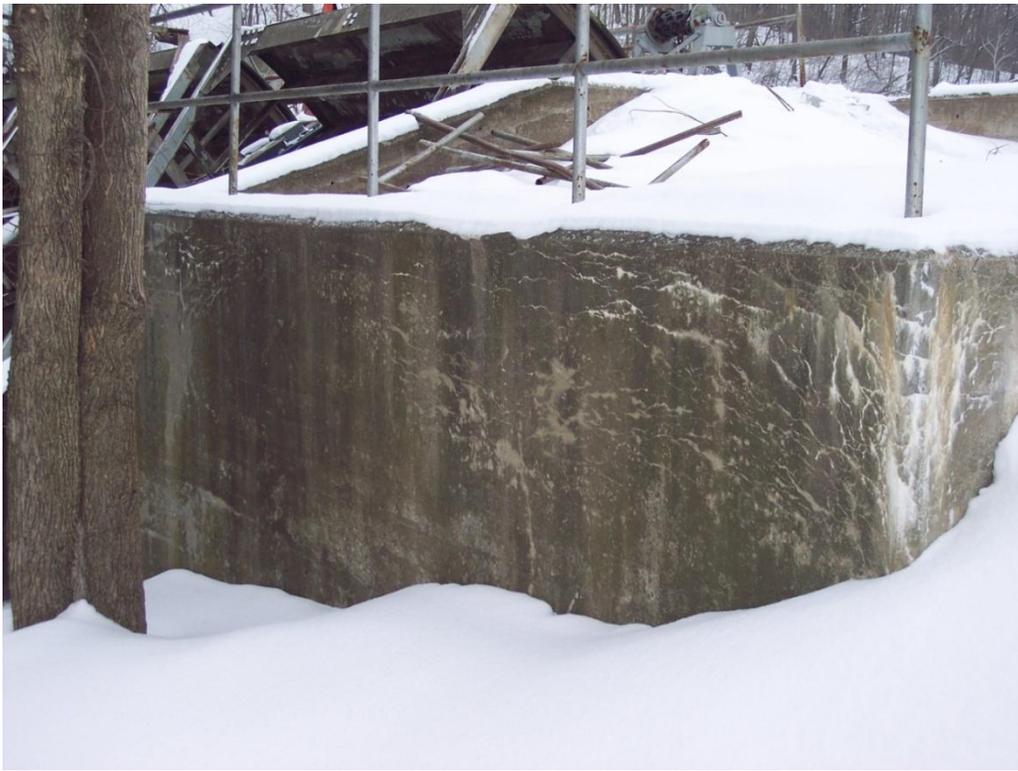
**Photo No. 15 – Previously-Patched Deteriorating Concrete, Northeast Wing Wall**

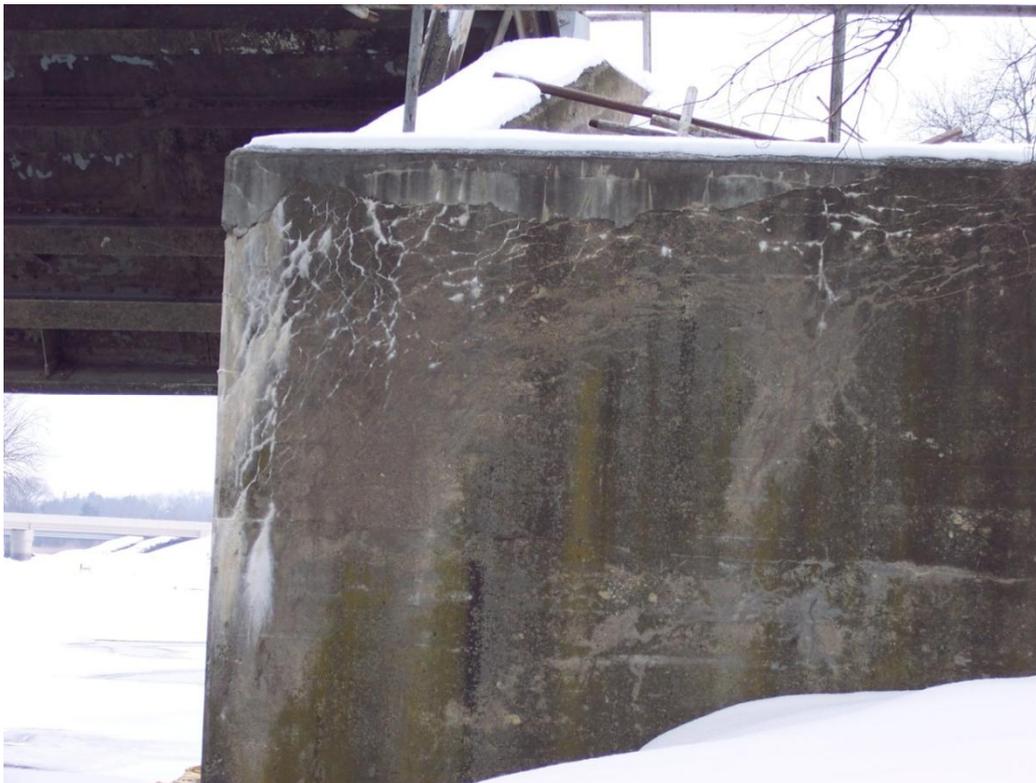
A tree (approx. 12" diam.) is growing adjacent to the east wing wall of the north abutment. See Photo No. 16.

**Photo No. 16 – Deteriorating Concrete, Northeast Wing Wall**

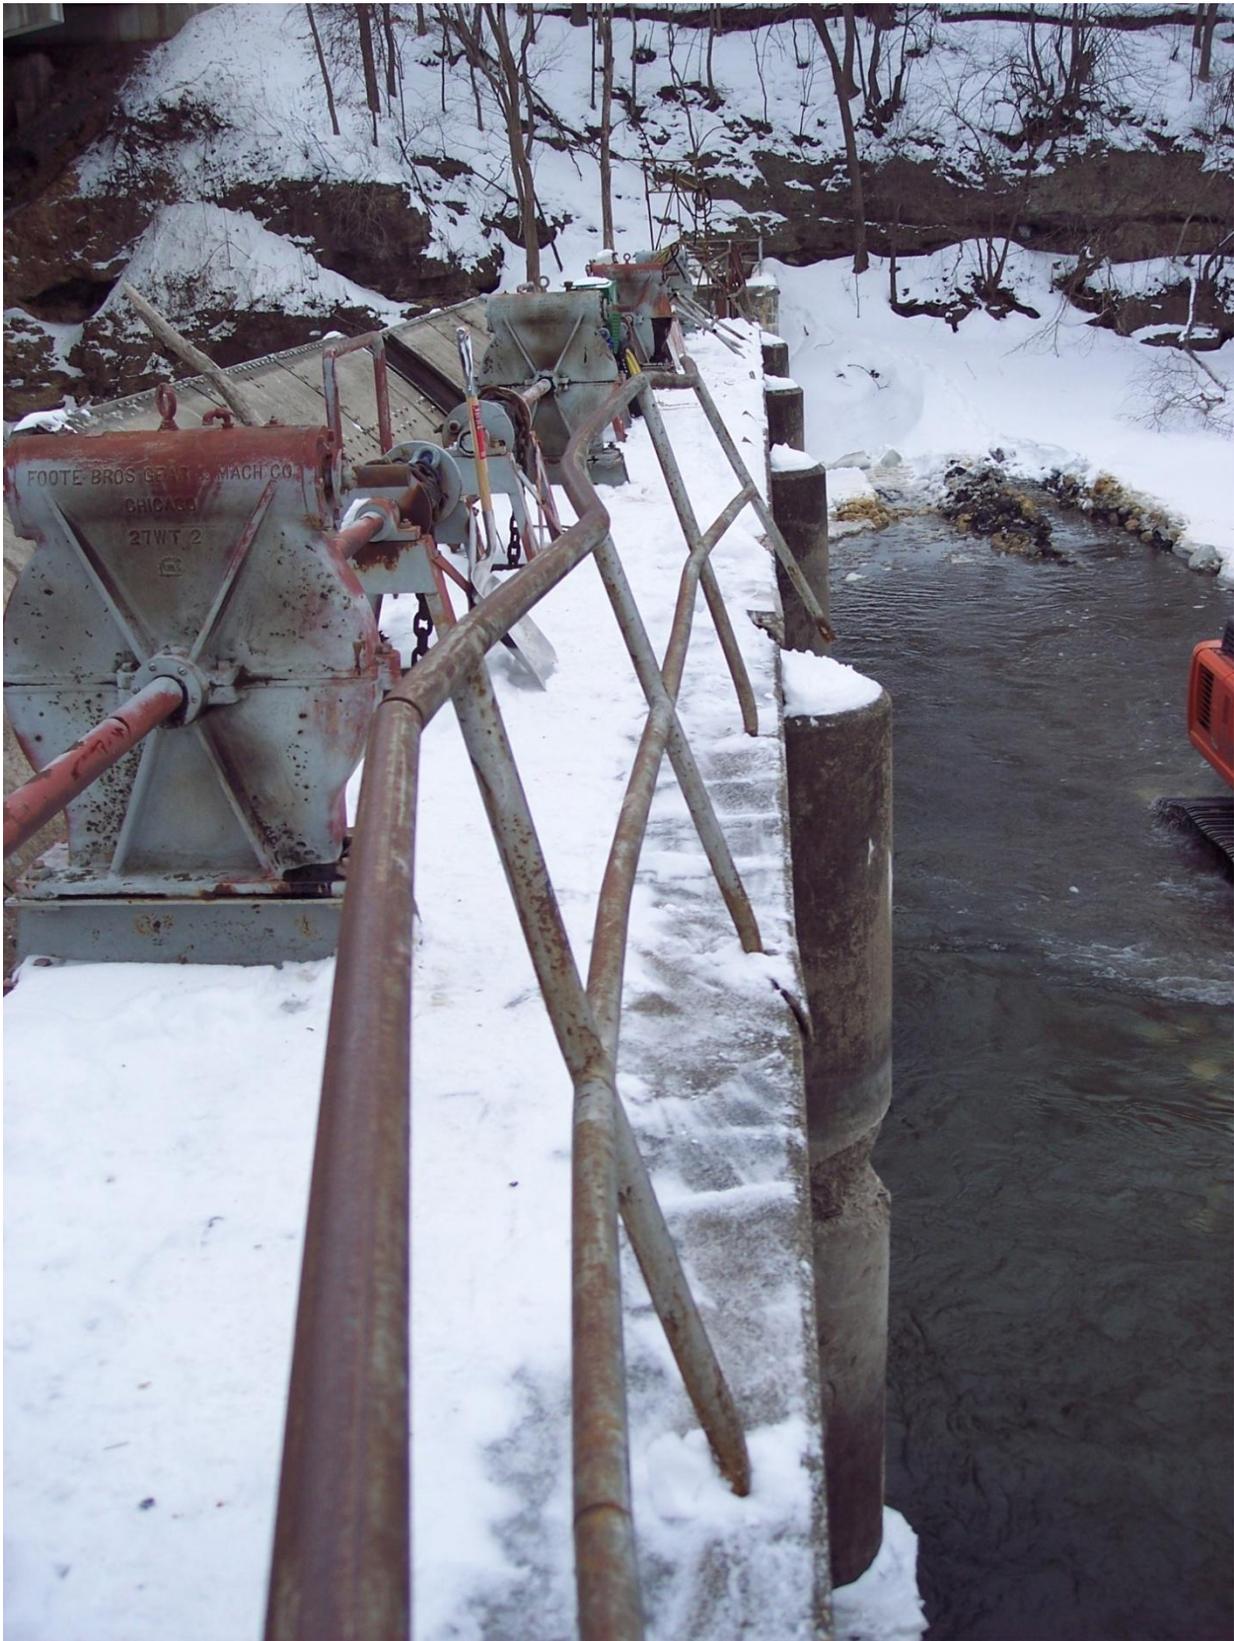
5. The upstream face of the walkway was sighted (visually) to determine whether any differential horizontal movement had occurred. No misalignment was observed. See Photo No. 17.

**Photo No. 17 – No Misalignment Visible Along Maintenance Walkway**

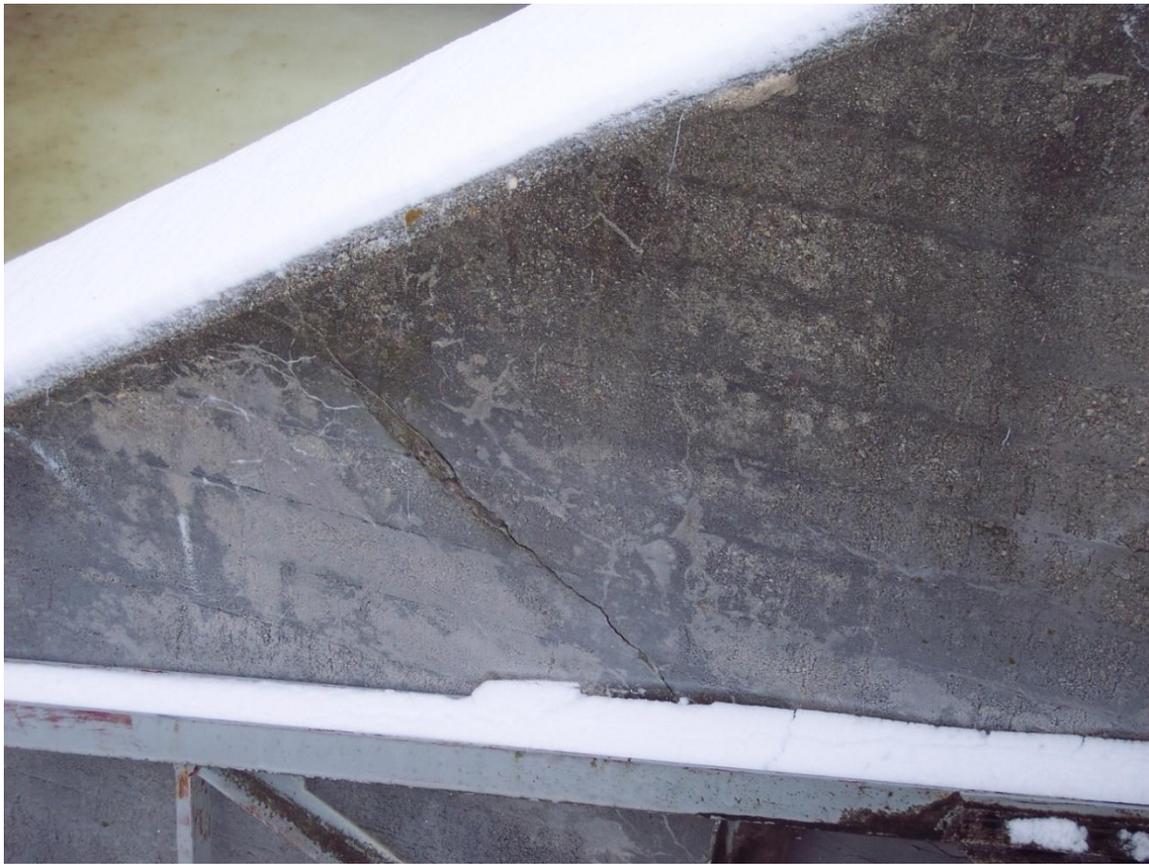
**Photo No. 18 – Cracked Left Wall of Main Spillway**

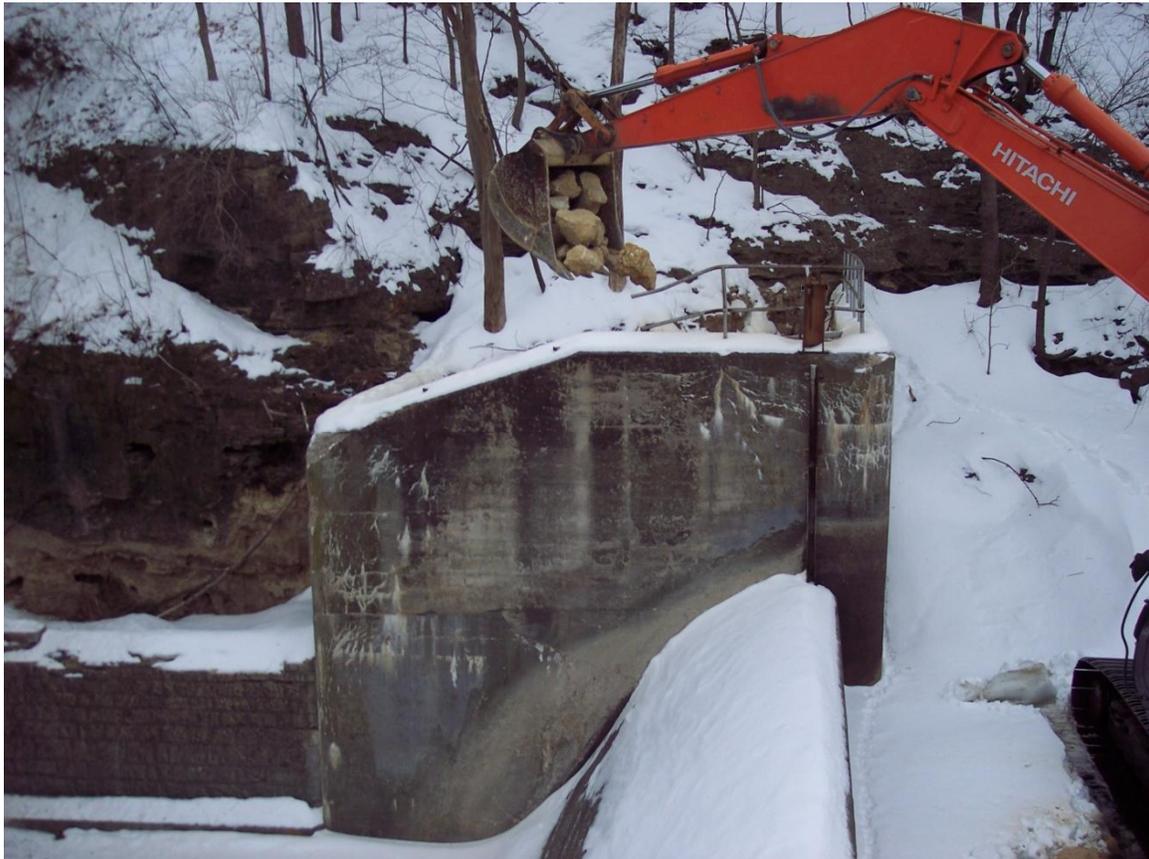
Surface web-cracking with efflorescence (white chalky substance) was observed in the faces of the right abutment wall, indicating that water was penetrating the concrete and that spalling is likely to begin soon. See Photo No. 19.

**Photo No. 19 – Backfilling Operations at South (Right) Abutment**

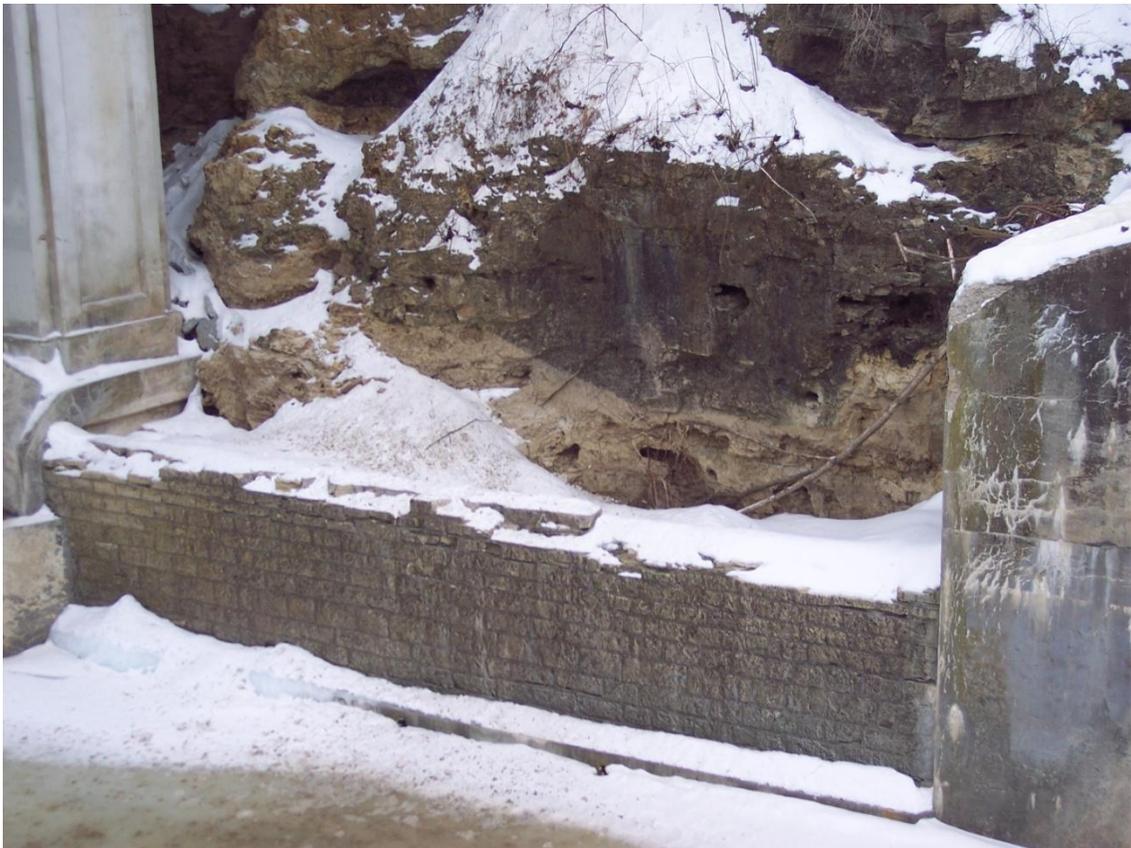
Downstream channel wall, on the right side, also appeared to have lost backfill material, and the exposed surface of bedrock appeared very weathered. Closer inspection could not be performed due to accessibility and snow coverage. See Photo No. 20.

**Photo No. 20 – Downstream Channel Wall and Deteriorated Bedrock**

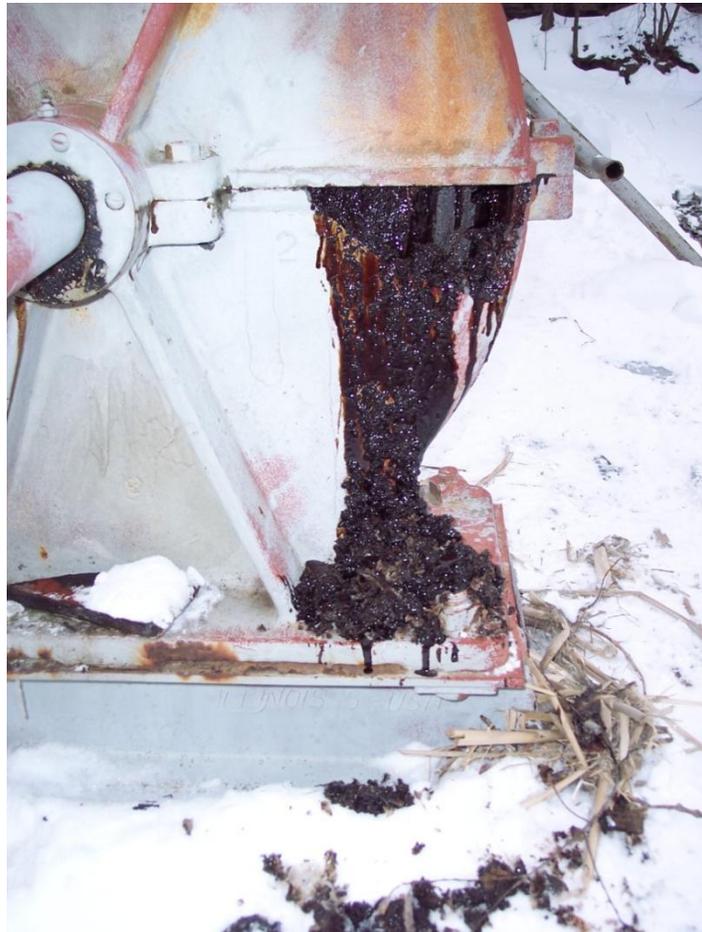
6. Radial gates, lifters and chains, with some notable exceptions, appeared to be in good condition and to operate properly. Gate No. 1 could not be opened due to a damaged lifting mechanism. No distress, distortion, or other damage was observed on any of the gates. See Photo Nos. 23 through 27. The geared operator for Gate No. 2 has been damaged and the housing leaks. See Photo No. 28.

**Photo No. 28 – Damaged Gate No. 2 Operator**

3. Gate #4 geared operator was damaged during preparations for the flood, and the lubricant has leaked out. To ensure the continued operability of the gate in the future, this must be repaired and the housing replaced. See Photo No. 28.

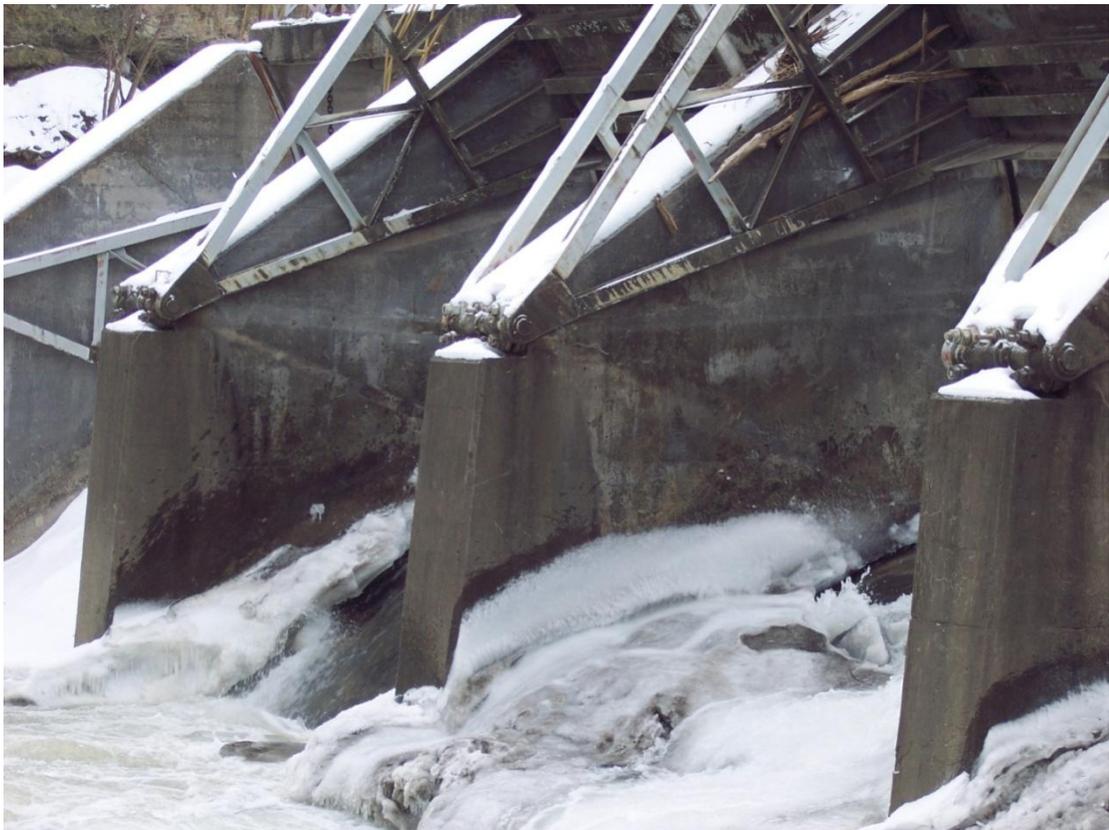
7. No distress or damage was observed at the gate trunnions and anchorages. See Photo Nos. 30 and 31.
8. Besides the complete wash-out of the embankment soils around the north end, the backfill soils were eroded from behind the south abutment walls and deposited downstream. The backfill replacement work was underway at the time of this inspection, and is expected to be complete at the time this report is issued. The backfill material consisted of large (12" or larger) limestone rip rap. See Photo No. 9.

**Photo No. 30 – Tainter Gate Trunnions**

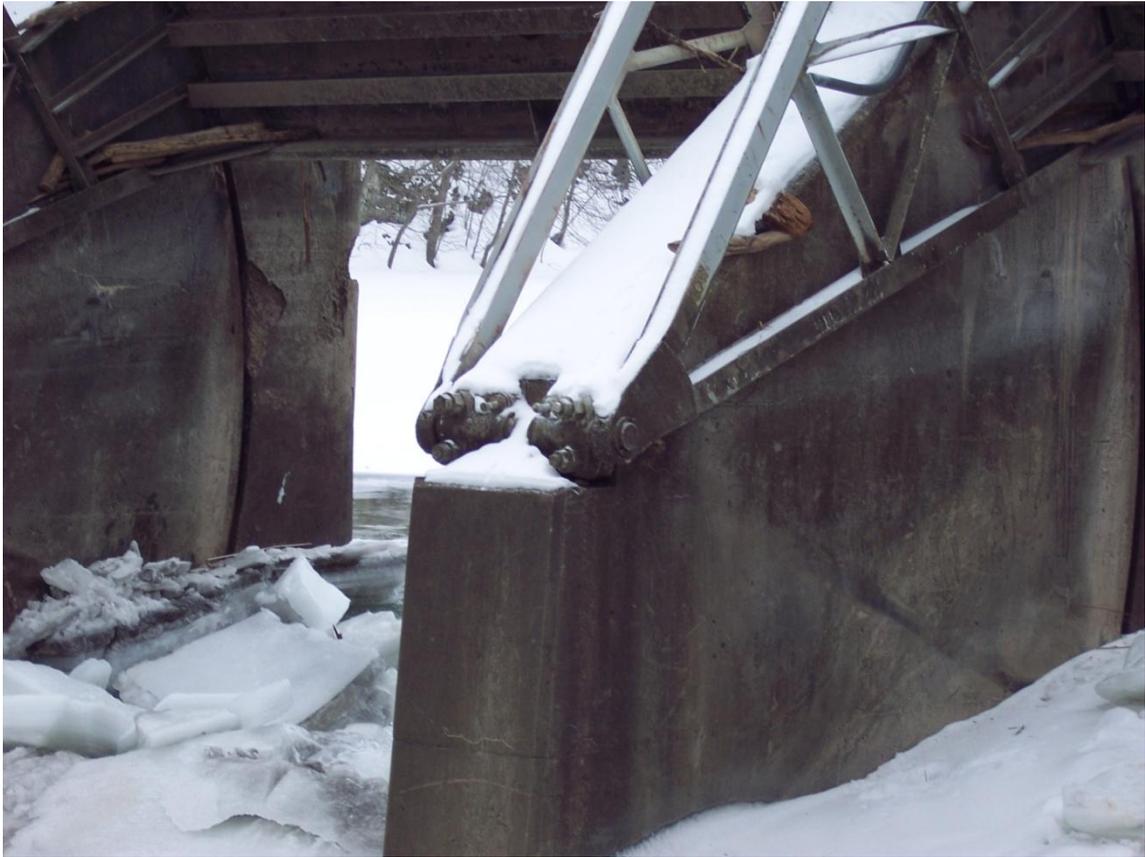
**Photo No. 31 – Trunnions for Gate No. 4 (left) and No. 5 (right).**
